## FAILURE OF FUJINUMA DAM DURING THE 2011 TOHOKU EARTHQUAKE

Daniel Pradel<sup>1</sup>), Joseph Wartman<sup>2</sup>), and Binod Tiwari<sup>3</sup>)

**Abstract:** The Mw=9.0 Tohoku Earthquake resulted in failures of the two dams impounding Fujinuma Lake, in Fukushima Prefecture. After the event, several mechanisms were postulated regarding the failure modes of the dams. The authors have performed numerical dynamic analyses whose principal aim was to determine the dams' likely failure mechanism. Our numerical analyses of the Fujinuma Main Dam predicted several meters of lateral displacement of the downstream face due to seismic shaking, i.e., sliding, and a corresponding large drop in the crest elevation. This drop rendered the dam vulnerable to overtopping which ultimately breached the dam. Additional numerical stability analyses also found that the Fujinuma Saddle Dam had a static factor of safety below unity under rapid drawdown conditions, and was therefore vulnerable to a rapid release of the reservoir water when the main dam was breached.

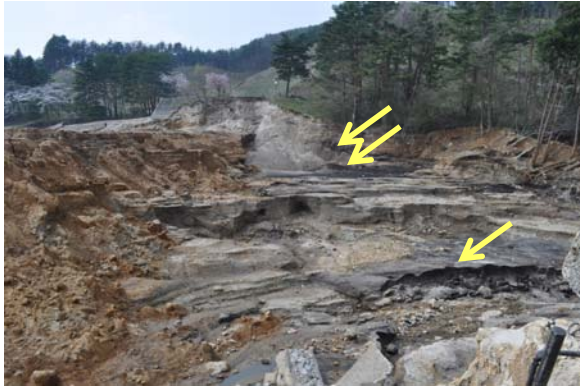
According to JCOLD (2011), dams generally behaved very well, suffering only minor to moderate damage during the Tohoku Earthquake. The single exception was the 18½ m high Fujinuma earthdam (Figure 1), which was constructed between 1937 and 1949, near Sukagawa City in Fukushima Prefecture (N37.302°, E140.195°). The excellent performance of Japanese dams during one of the largest earthquakes in recent history, attests to the excellence of Japanese dam construction and long term maintenance.

Figure 1 Photograph of the breached Fujinuma Main Dam (the arrows point to a layer of dark and organic residual soil)

Although a significant portion of the main dam had been washed away by overtopping, the EDS team was able to make key observations that revealed the nature of the dam construction and its likely mode of failure. For example, along the breached section, nearly vertical exposures up to 5m in height of cohesive fill materials and compaction layering were exposed (Figure 3). Furthermore, evidence of a translational sliding mechanism was observed along the right abutment which included a slightly elevated bulge and a large displaced block from the downstream face of the dam. Lastly, the breach exposed foundation materials at several locations along the base of the dam. Of particular interest to our team was a dark residual soil layer which blanketed the base of the dam and was also exposed downstream along the left abutment (Figure 1); this residual soil layer (paleo-soil) was rich in organics and had been locally reworked into compacted fill along the foundations (or base) of the dam.

Since no evidence of soil liquefaction was observed along the intact portions of the dam and abutments, our team concluded that the probable failure mechanism was a seismically induced landslide with a basal plane located through the highly organic residual soil layer. Please note that the GEER team proposed a similar mode of failure independently (Harder et al., 2011).

Based on their field observations, the EDS team reached the conclusion, that sliding of the downstream face probably occurred during the Tohoku Earthquake. The seismic displacements must have been sufficient to lower the crest of the dam and allowed, initially, a slow release of water over the crest of the dam. Overtopping caused erosion of the top of the dam, which culminated in a full blown breach, and the overtopping which photographed 25 minutes after the Earthquake and reported in EERI (2011).

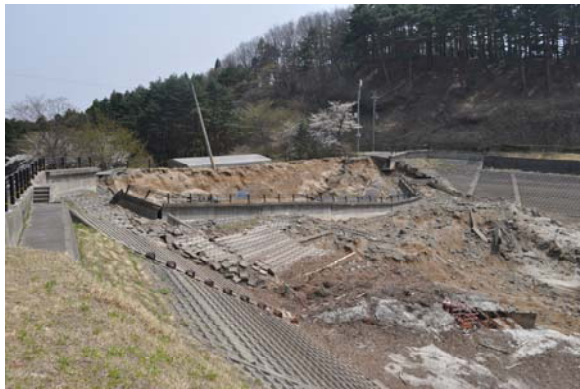
A small Saddle Dam at the site which retained the southeast end of Fujinuma Lake also failed as a result of the earthquake. This secondary dam was not breached and experienced a slope failure towards the reservoir (Figure 2). According to EERI (2011) the saddle dam' failure could have been caused by strength loss during the earthquake, i.e., sliding, or by rapid drawdown from the rapid release of the reservoir water through the main dam breach.

Figure 2 Photograph of the failed Fujinuma Saddle Dam

Although the failure of the Saddle Dam (Figure 2) is reminiscent of the 1971 Lower San Fernando Dam liquefaction failure, careful examination of the downstream face of the dam and of the abutments did not reveal evidence of sand boils, lateral spread, or liquefaction related effects.

A LIDAR investigation by Kayen et al. (2011) found little deformation on the slope immediately adjacent to the dam. Hence, our team concluded that the failure was probably due to rapid drawdown, i.e., caused by the sudden release of the reservoir after the main dam failed. Please note that the GEER team (Harder et al., 2011) reached a similar conclusion independently.

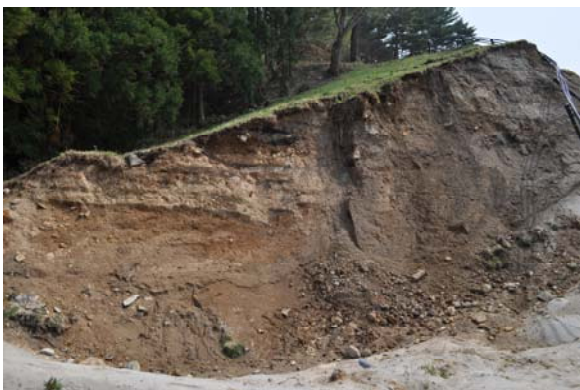
Figure 3 Photograph of a near vertical section of the Fujinuma Main Dam breach (looking South).

For sliding and permanent displacement to occur a hypothesis of the shear strength of the materials was required in our model. Based on the height of the near vertical sections (measured angles ranged from 60° to vertical) we estimated that fills had a minimum static undrained shear strength of 20 kPa. This strength was adopted along the upstream face of the reservoir and doubled along the unsaturated downstream face to account

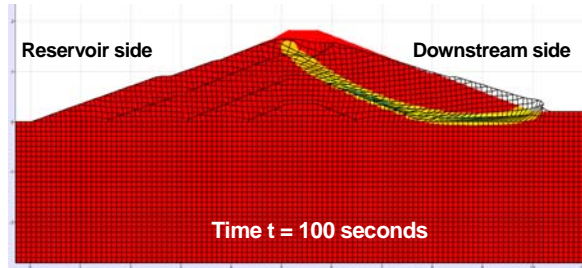
Figure 4 Mesh used in our dynamic analyses of the Fujinuma Main Dam and predicted mode deformation (displacements are exaggerated). Shear strains contours are also shown.

To evaluate the likelihood of the postulated mechanism, we performed a relatively simple dynamic numerical analysis using the computer program FLAC version 7.0 (Itasca, 2011). Figure 4 depicts the mesh used in our analysis, as well as the predicted mode of deformation. The ground motions used in our analyses were obtained from several stations of the KNET network where bedrock was shallow, namely stations FSK015 (PGA=0.28g) TCG001 (PGA= 0.4g) and FSK025 (PGA=0.15g). Due to manuscript length limitations only the numerical results using the FSK015 motions are presented herein (the velocities from FSK015 depicted in Figure 5 were the input at the base of our FLAC model). To allow damping to vary with time during the earthquake, we adopted, for simplicity, hysteretic damping (Figure 6) using as backbone shear moduli based on the “upper range” curves by Seed & Idriss (1970). The numerical approximation shown in Figure 7, was considered reasonable for the on-site cohesive materials.

Our numerical analyses generally predicted meters of lateral displacement in the downstream direction due to seismic shaking (Figure 4), with slippage occurs taking place along the base of the dam, i.e., where the dark residual soil and fill were present (Figure 1). More importantly the model

showed a corresponding large drop in the crest elevation. The predicted drop in crest elevation would have rendered the dam very vulnerable to overtopping. This mode of failure is consistent with the conclusions of our teams' observations, Harder et al. (2011), and is one of the postulated mechanisms in EERI (2011). Lastly, the proposed failure mode is also consistent with the photograph taken by M. Yoshizawa approximately 25 minutes after the earthquake (contained in the EERI (2011) report), which does not show evidence of a slide towards the reservoir.

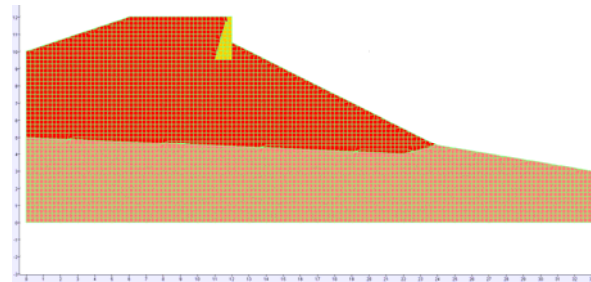
To evaluate the likelihood of the rapid drawdown failure mechanism postulated by our team, we conducted a simple analysis of the stability of the saddle dam by the strength reduction method. The mesh used and predicted mode of failure are shown in Figures 9 and 10. In our analysis we assumed that both dams were built at the same time with similar compacted fill materials, hence, we used the static shear strength shown in Figure 8.

Figure 9 Mesh used for the rapid drawdown analyses of the Fujinuma Saddle Dam.

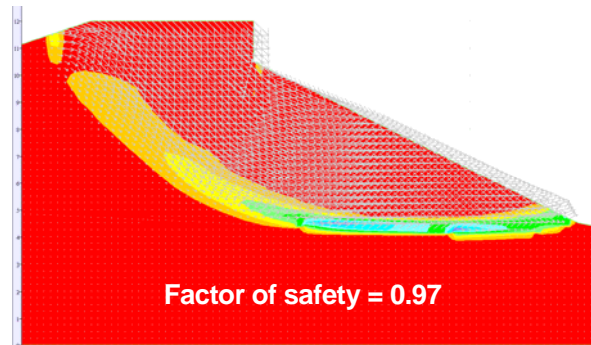
Figure 10 Mode of failure predicted by the Strength Reduction Method during rapid drawdown. Also shown are shear strain contours and displacement vectors)

Our numerical stability analyses found a static Factor of Safety of 0.97, which indicates that the saddle dam was vulnerable to rapid drawdown mode of failure. In our opinion, the rapid release of the reservoir water through the main dam breach was the likely cause of failure.

A rapid drawdown failure is one of the mechanisms postulated by EERI (2011). It is consistent with both our team's original conclusions and those of the GEER team (Harder et al. 2011). Please note that the absence of permanent displacements and distress in the downstream face of the saddle dam strongly supports a rapid drawdown failure, versus a mode of failure related to strength loss caused by earthquake shaking.

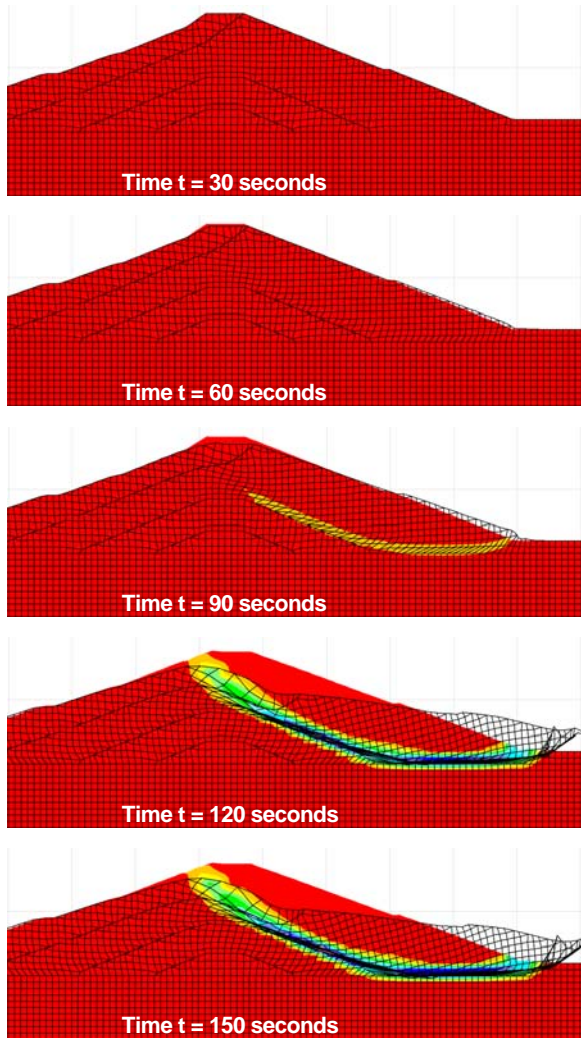
Figure 11 Predicted deformations and shear strains contours of Fujinuma Main Dam using static undrained shear strengths (displacements are exaggerated five times; maximum displacement at  $t = 150$  seconds is approximately 2 m).

predicted large lateral displacements (meters) of the downstream face due to seismic shaking, i.e., sliding, and a corresponding major drop in the crest elevation (Figure 11). This drop rendered the dam vulnerable to overtopping and ultimately to failure.
