GROUND IMPROVEMENT BY STONE COLUMNS AND SURCHARGE AT A TANK SITE

ABSTRACT

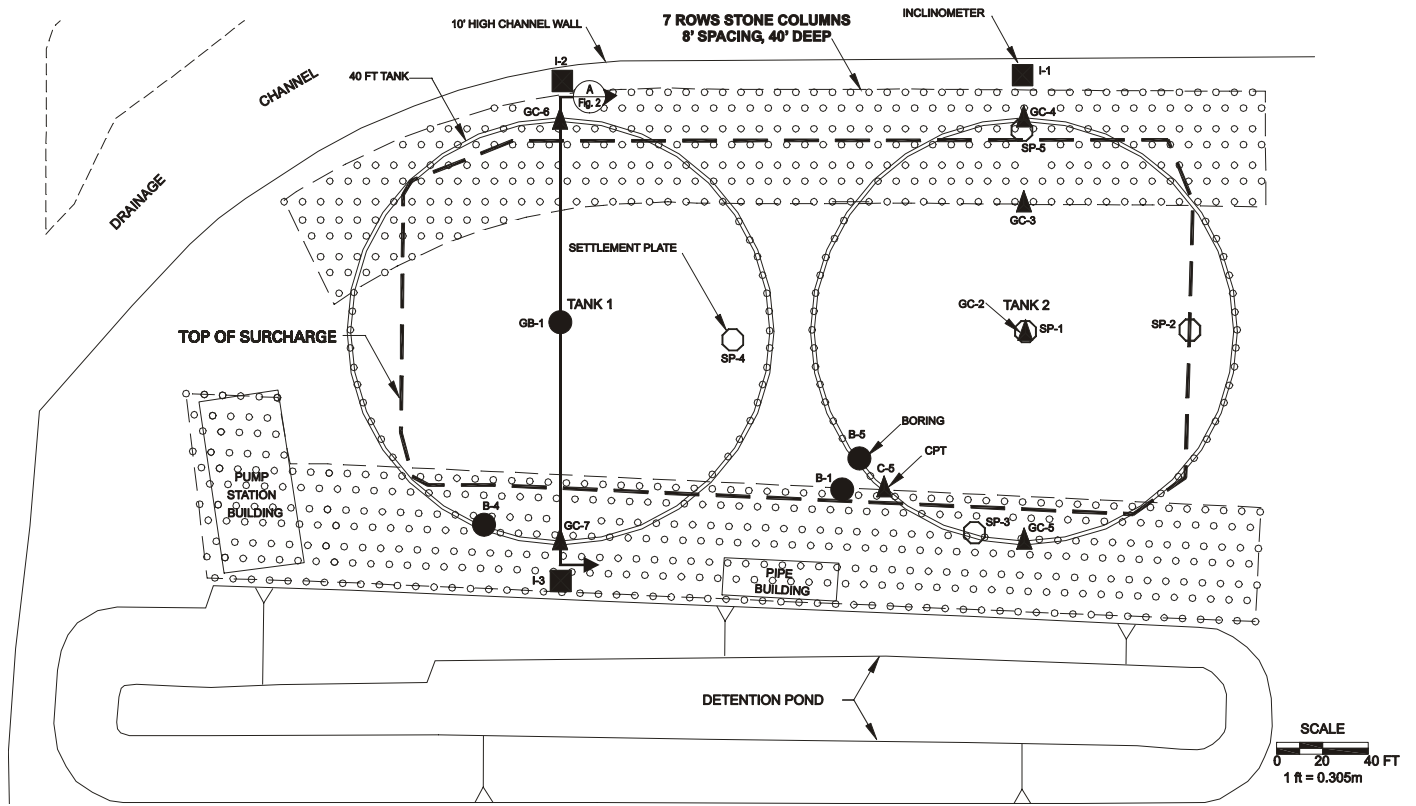
Fig. 1. Site Layout

- The lot is roughly rectangular in shape, measuring about 560 ft (171 m) in the east-west direction and 330 ft (101 m) in the north-south direction. Site layout is shown in Fig. 1. The tank site has grades ranging between El. 33 to El. 35 feet (10.1 to 10.7 m).
- A new detention pond with a depth ranging from 6 to 10 ft (1.83 to 3 m) and 3:1 (horizontal to vertical) side slopes was planned to be constructed about 25 ft (7.6 m) south of the reservoirs.
- The site is bounded on the north, and along the northwest corner, by a 10-ft (3-m) deep concrete-lined drainage channel with vertical side retaining walls.

The vertical 10-ft (3-m) high wall of the drainage channel is located about 25 ft (7.6 m) north of the two reservoirs (Fig. 1). Tank foundations were proposed at roughly 10 ft (3 m) above channel invert elevation. In addition, a detention pond was proposed about 25 ft (7.6 m) south of the two reservoirs. The detention pond was proposed with 3:1 (horizontal to vertical) side slopes and the bottom of the pond was up to 10-ft (3m) below the tank foundations. The presence of these low-lying areas results in reduced lateral stability compared to tanks on level ground. Results of stability analyses performed by PCSTABL/5M are shown in Fig. 3. For seismic stability, we used a pseudo-static coefficient of 0.15, and we reduced the shear strength of the soft to firm clay to 80% of the static shear strength. The calculated factors of safety for static and seismic conditions are 1.3 and 0.9, respectively, and are lower than the normally used values of 1.5 and 1.1, respectively. Since the calculated factor of safety for pseudo-static analysis was less than 1.1, we estimated that potential for large lateral movements using simplified Newmark-type analysis (Blake et al., 2002) was present during the design earthquake.

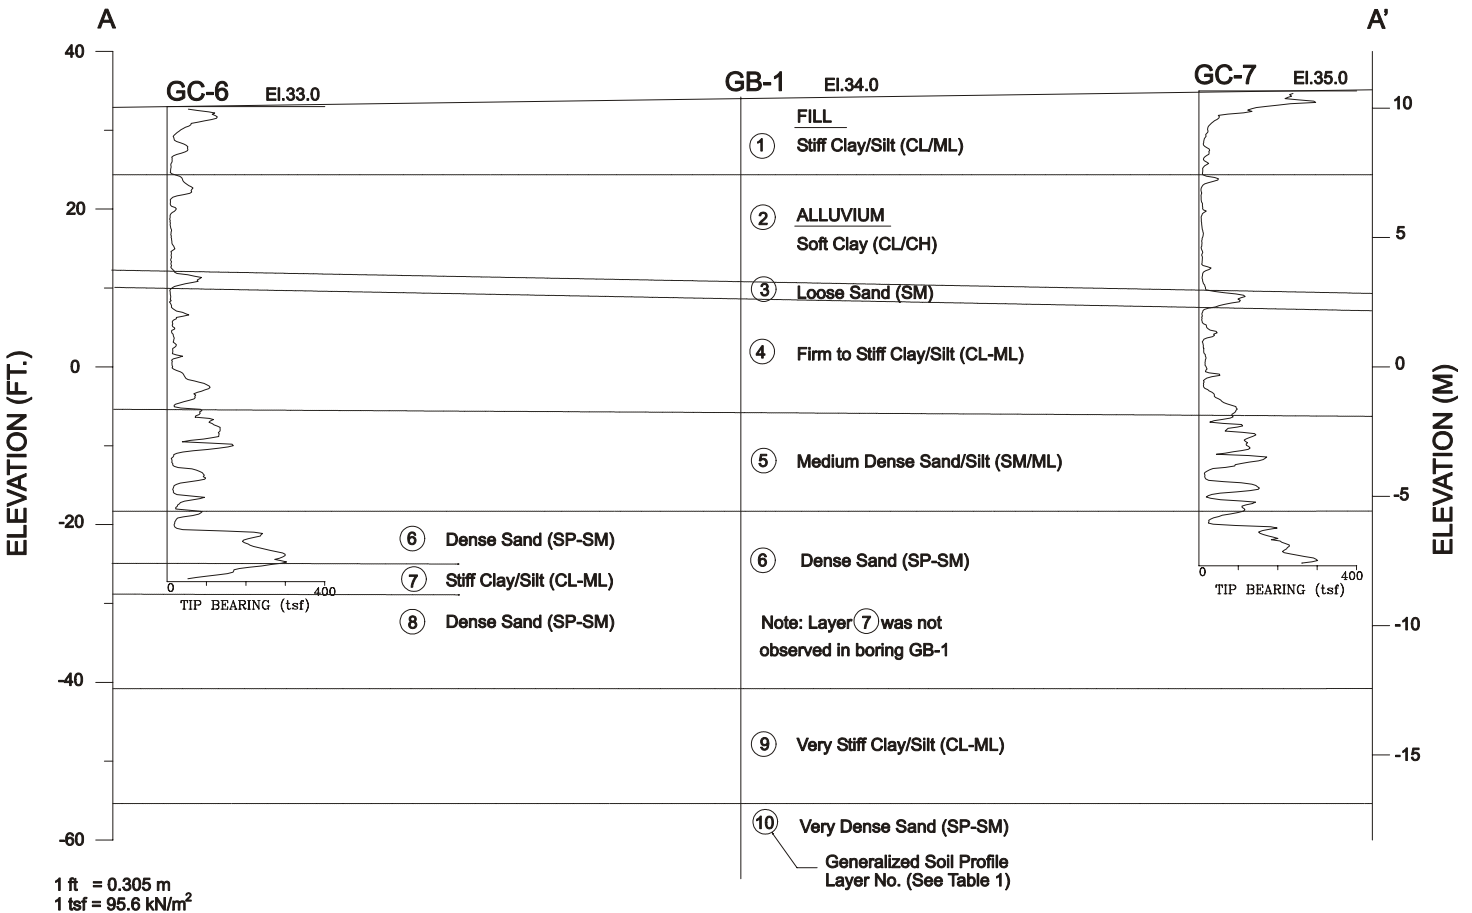
Fig. 2. Generalized Soil Profile

Based on data from the borings and CPTs, the soil profile is relatively uniform. Beneath a cap of stiff clay/silt man-made fill soils, deep alluvial sediments underlie the site. Above El. -18 ft (5.5 m), the alluvial sediments consist primarily of compressible soft to stiff clay/ silt layers, with isolated zones of loose to medium dense sands. Below El. -18 ft (5.5 m), the sediments consist of dense to very dense sands and stiff clays. We developed a generalized soil profile including strength and compressibility parameters shown in Table 1. A generalized cross-section illustrating the soil profile is shown in Fig. 2. The groundwater was present at depths ranging from 10 to 16 ft (3 to 4.9 m) below existing grades.

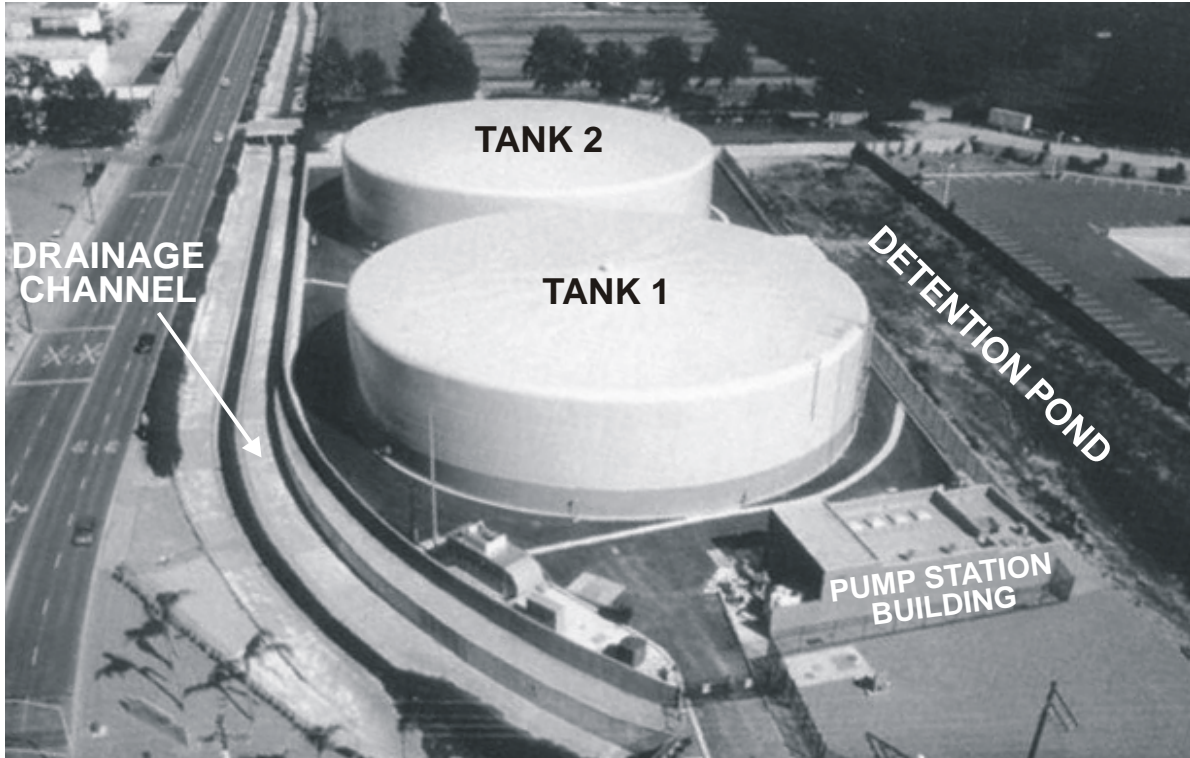
Photo 1. Aerial View of Tanks

The two tanks, pump station, and other facilities are shown in Photo 1.

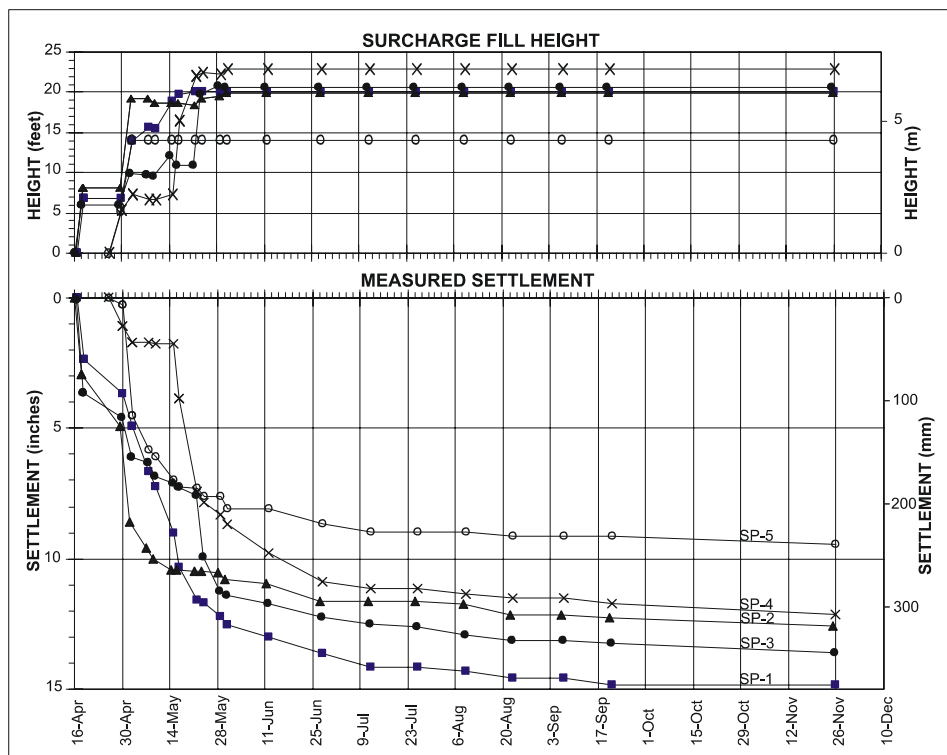
Fig. 4. Surcharge Settlement

The settlement data from plates SP-1 through SP-5 is presented in Fig. 4. The following observations can be made from a review of Fig. 4.

- The measured settlement ranged between 9.1 and 14.6 inches (231 and 371 mm). The smallest settlement at 9.1 in. (231 mm) for plate SP-5 is for a plate on the slope. Plate SP-4 was located in an area where previous fill had been stockpiled and thus, has less settlement. The settlement at the other three plates ranges between 12.2 and 14.6 inches (310 and 371 mm). These values compare favorably with the predicted settlements under the surcharge.
- The data in Fig. 4 indicates that the settlement had leveled off in about 100 days after the completion of the surcharge or about 5 months after the start of the surcharge. Depending on the rate at which the surcharge was placed, 90% of the settlement was completed in the first 30 to 45 days after the completion of the surcharge.
