SOIL IMPROVEMENT BY PRECOMPRESSION AT A TANK FARM SITE IN CENTRAL JAVA, INDONESIA

Kul Bhushan, President, Group Delta Consultants, Inc., Aliso Viejo, CA, USA
Carlos V. Amante, Project Engineer, Group Delta Consultants, Inc., Aliso Viejo, CA, USA
Ramzi Saaty, Project Manager, Fluor Daniel, Inc., Aliso Viejo, CA, USA

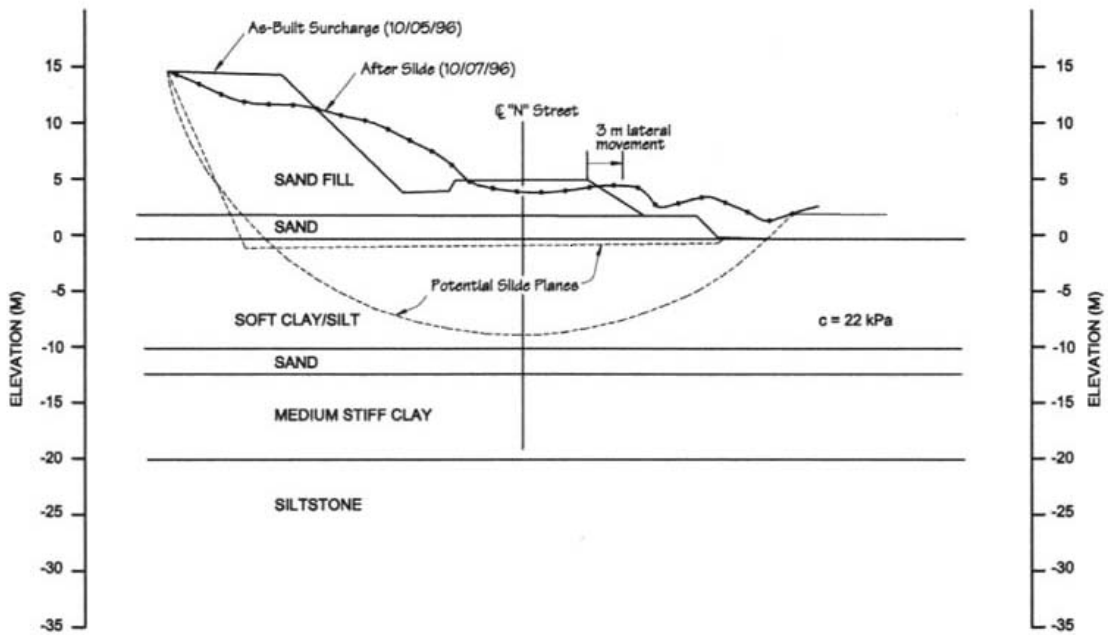
Figure 9. As-built surcharge and after-slide conditions for Tanks 305/307

A slide failure occurred in the surcharge fill at the location of Tanks 305 and 307. The surcharge in the area of these tanks was raised from about El. +2 m to El. +14.88 m during a period of about one month. After a heavy rainfall, the surcharge moved laterally to the north by about 3 m and disrupted the existing ditch located about 50 m to the north of Tank 305. An approximate cross section of the as-built surcharge in the area of Tanks 305 and 307 and the condition after the slide are shown in Figure 9.

The factor of safety for the full surcharge height of 14.88 m was calculated to be less than 1.0 for a slide plane along the top of the soft clay layer. The rapid placement of the fill did not provide adequate time for the consolidation of the clay and resulting strength increase. In addition, the presence of the ditch to El. -0.5 m provided a shorter failure path along the top of the soft clay, thus further reducing the factor of safety.

After the slide, various options including use of piles and re-routing of the ditch were considered for remedial measures to support Tanks 305 and 307. The option selected included:

- Removing surcharge in the area and installing new wick drains,
- Resurcharging area of Tanks 305 and 307 in stages,
- Installing inclinometers and additional settlement monuments to measure settlement and lateral ground movement during surcharging,
- Surcharging area of roadway north of Tanks 305 and 307 to increase shear strength,
- Making drainage modifications to prevent ponding of water,

- Developing a monitoring program to assess the settlements, pore pressures, and lateral ground movements, and
- Verifying the shear strength increase by performing cone penetration tests.
