## FAILURE OF FUJINUMA DAM DURING THE 2011 TOHOKU EARTHQUAKE

Daniel Pradel<sup>1</sup>), Joseph Wartman<sup>2</sup>), and Binod Tiwari<sup>3</sup>)

**Abstract:** The Mw=9.0 Tohoku Earthquake resulted in failures of the two dams impounding Fujinuma Lake, in Fukushima Prefecture. After the event, several mechanisms were postulated regarding the failure modes of the dams. The authors have performed numerical dynamic analyses whose principal aim was to determine the dams' likely failure mechanism. Our numerical analyses of the Fujinuma Main Dam predicted several meters of lateral displacement of the downstream face due to seismic shaking, i.e., sliding, and a corresponding large drop in the crest elevation. This drop rendered the dam vulnerable to overtopping which ultimately breached the dam. Additional numerical stability analyses also found that the Fujinuma Saddle Dam had a static factor of safety below unity under rapid drawdown conditions, and was therefore vulnerable to a rapid release of the reservoir water when the main dam was breached.

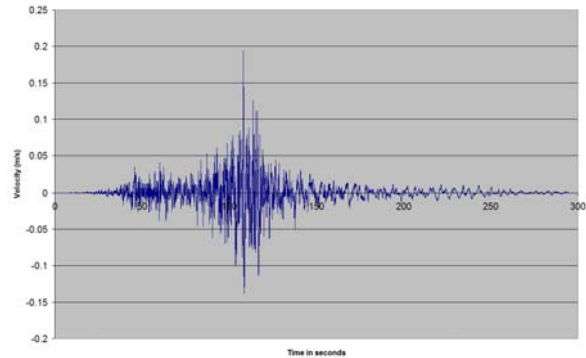
To evaluate the likelihood of the postulated mechanism, we performed a relatively simple dynamic numerical analysis using the computer program FLAC version 7.0 (Itasca, 2011). Figure 4 depicts the mesh used in our analysis, as well as the predicted mode of deformation. The ground motions used in our analyses were obtained from several stations of the KNET network where bedrock was shallow, namely stations FSK015 (PGA=0.28g) TCG001 (PGA= 0.4g) and FSK025 (PGA=0.15g). Due to manuscript length limitations only the numerical results using the FSK015 motions are presented herein (the velocities from FSK015 depicted in Figure 5 were the input at the base of our FLAC model). To allow damping to vary with time during the earthquake, we adopted, for simplicity, hysteretic damping (Figure 6) using as backbone shear moduli based on the “upper range” curves by Seed & Idriss (1970). The numerical approximation shown in Figure 7, was considered reasonable for the on-site cohesive materials.

Figure 5 Velocity input at the base of the numerical model for the FSK015 recording (PGA=0.28g)

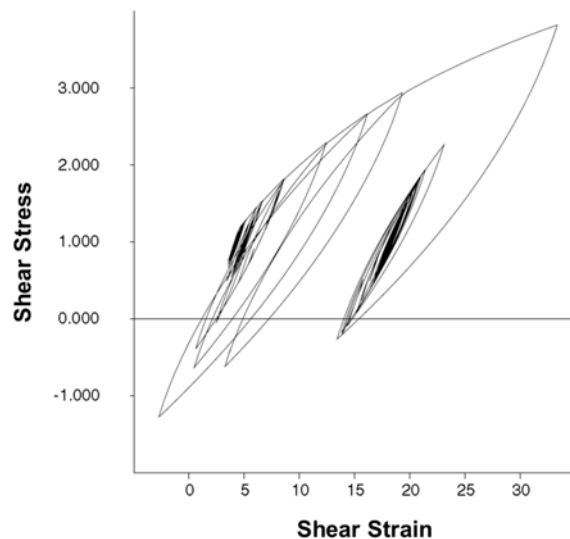
Figure 6 Hysteretic damping

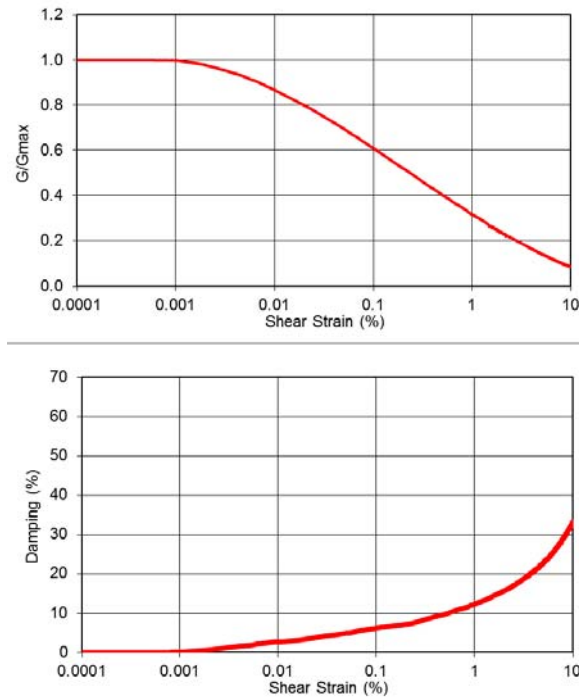
Figure 7 Backbone modulus reduction and damping ratios used for hysteretic damping

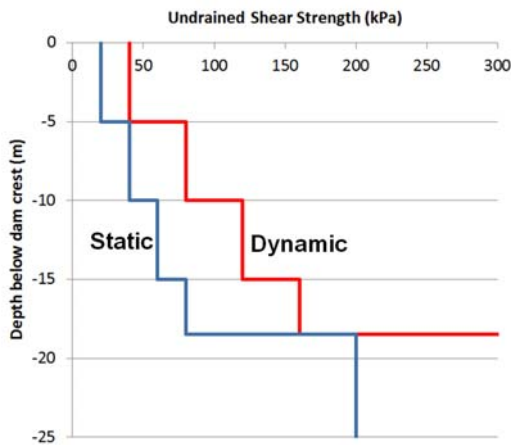
For sliding and permanent displacement to occur a hypothesis of the shear strength of the materials was required in our model. Based on the height of the near vertical sections (measured angles ranged from 60° to vertical) we estimated that fills had a minimum static undrained shear strength of 20 kPa. This strength was adopted along the upstream face of the reservoir and doubled along the unsaturated downstream face to account

for the increase due to soil suction. Within the saturated core of the dam the increase of strength with depth was based on an undrained cohesion to total stress ratio,  $S_u/\sigma = 0.25$ . Please note that no differentiation was made in terms of strength between the natural residual clay (paleo-soil) and the dam’s compacted fill.

Ishihara (1996) has shown that the dynamic strength of cohesive materials is larger than the static strength. At low confining stresses Ishihara’s tests on Nanamawari Izu clay showed an increase of up to 100% when subjected to a small number of loading cycles and almost no increase with large number of cycles. The range of adopted strength profiles used in our study are shown in Figure 8.

Figure 8 Range of adopted static and dynamic shear strengths

Our study of the saddle dam stability also suggests that the undrained strengths in Figure 8 which were used for the two dams are reasonable, as they explain both the Saddle Dam failure and the maximum near vertical heights of fill on the main dam.
